**The University of Idaho
Administration Building
Preservation and Design Guidelines
Master Plan**

**The University of Idaho
Administration Building
Preservation and Design Guidelines
Master Plan
May 2000**

BOLA Architecture + Planning, Seattle

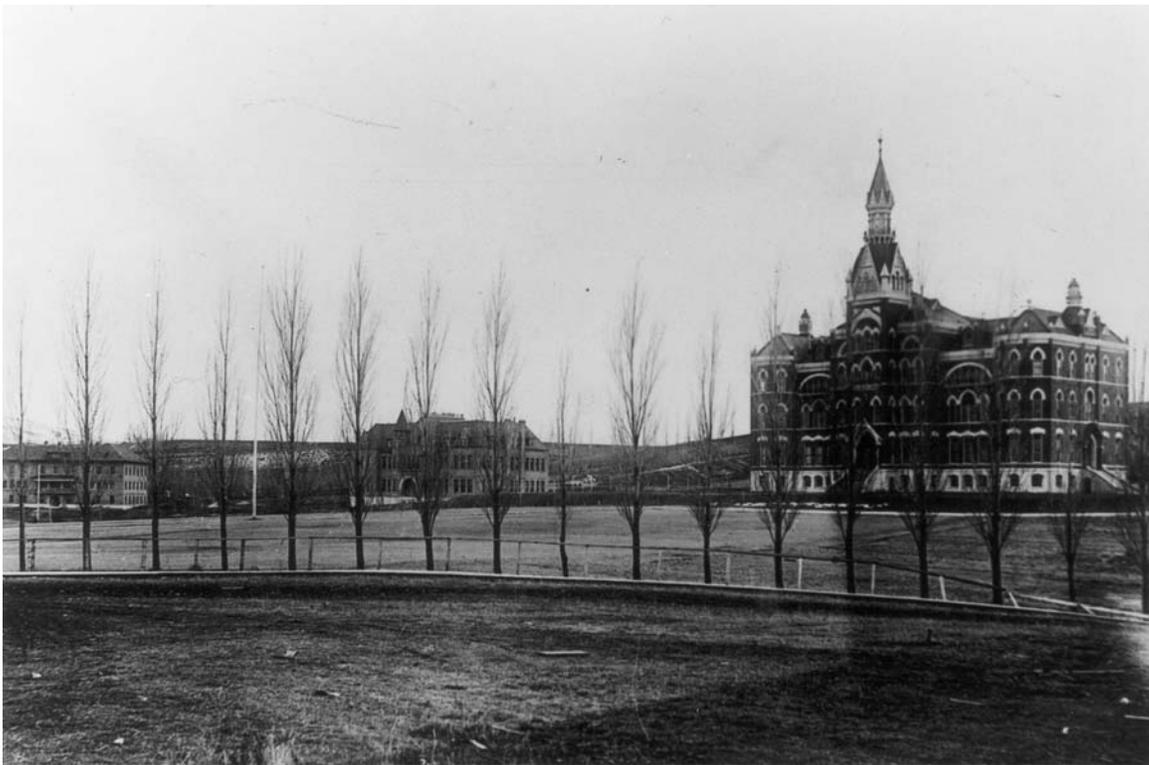
The campus in 1903 with the first, Romanesque Revival styled Administration Building. Photo No. 1-2-9.

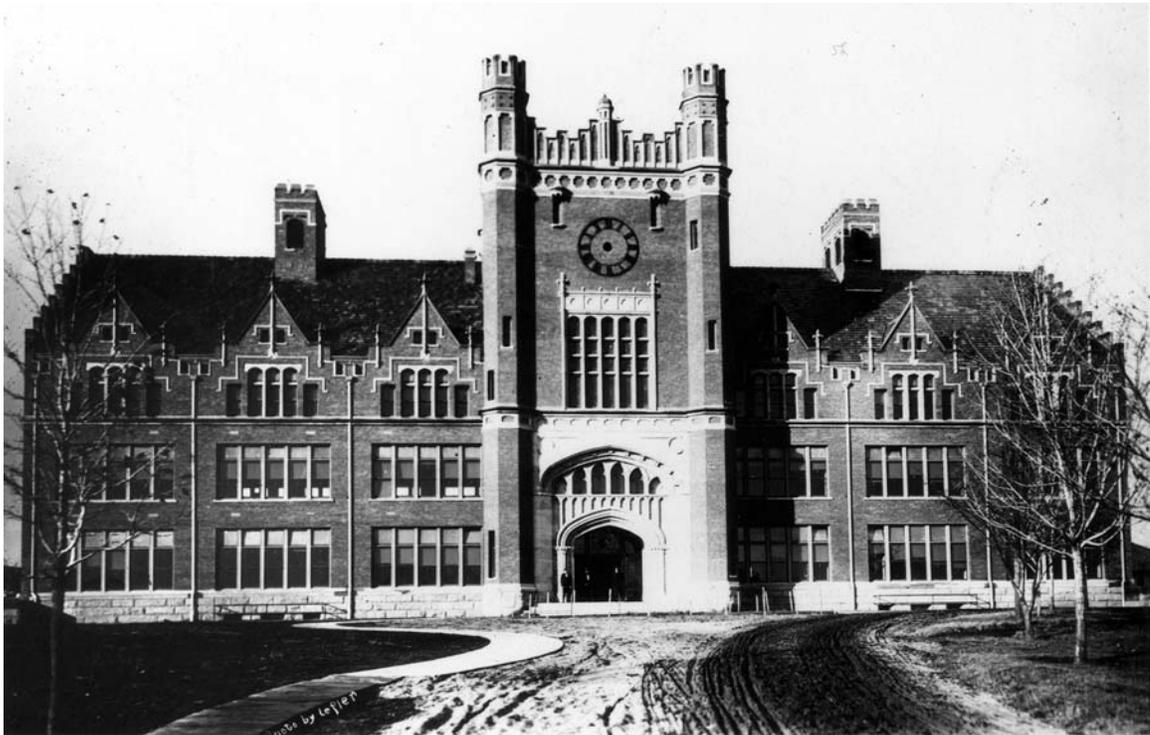
*Original construction consisted of a central tower and three bays to each side, referred to as the "East Wing."
Photo No. 1-52-005.*

- The new Administration Building was constructed in phases on approximately the same site as the original building. Boise architect J. E. Tourtellotte, working closely with University President James McClean, conceived of a three-story Gothic structure with a central 130-foot tower. The State Legislature provided \$275,000 in funds for the initial phase. Responding to budget concerns, the tower was scaled back to its present 80-foot height. The clock face was added to the tower exterior in 1912.

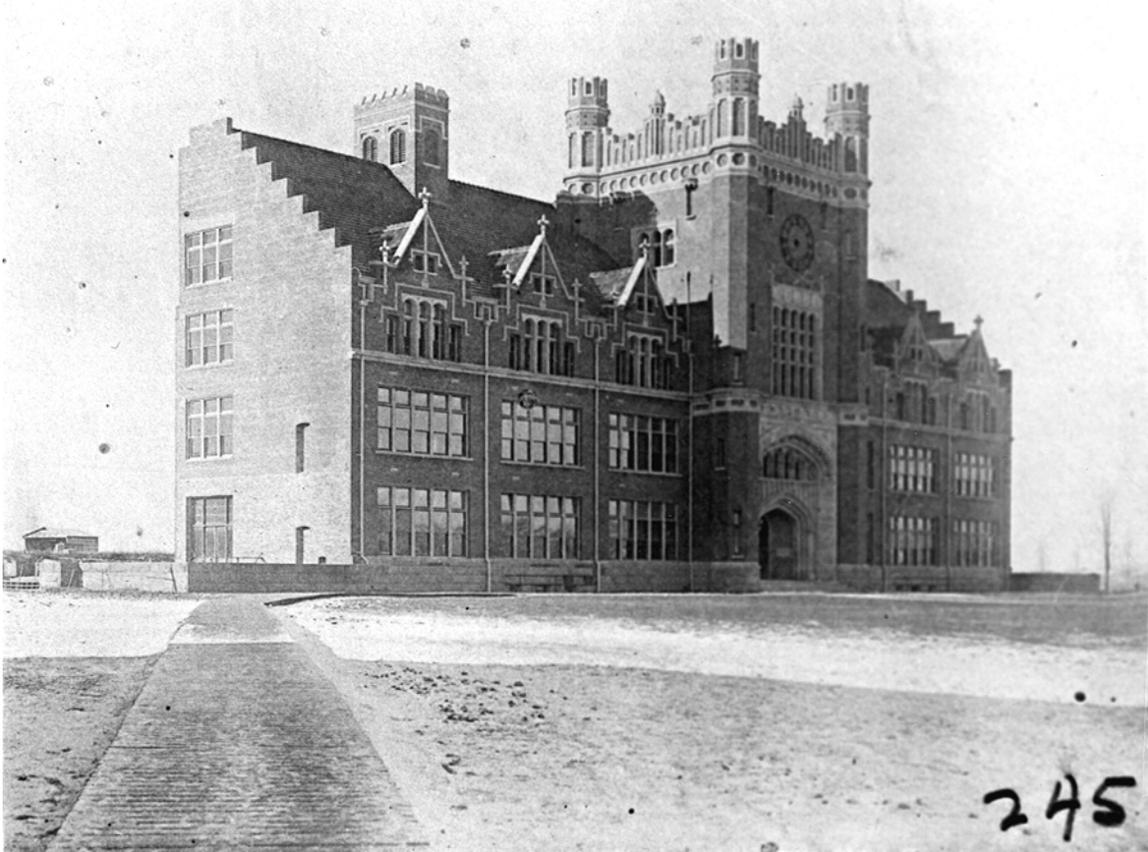
The original construction consisted of the East Wing and resulted in the truncated south end of the building as shown in this view ca. 1909. Note masonry base built on both sides of the building for subsequent construction and projecting finials at front facade roofline. Photo No. 245.

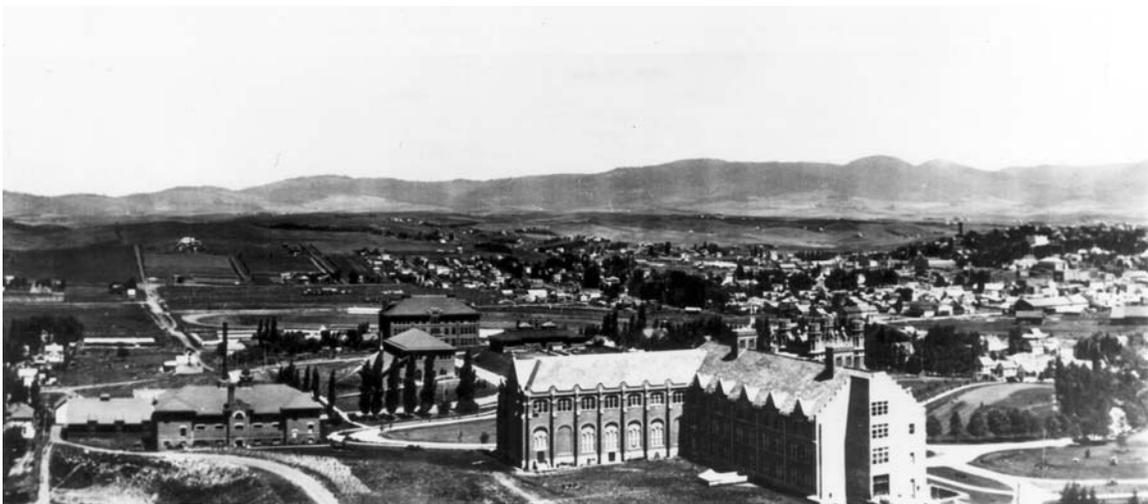
Below, an aerial view of the campus, ca. 1912, which shows the building in its campus setting and completion of the north Auditorium wing. Photo 1-2-30.

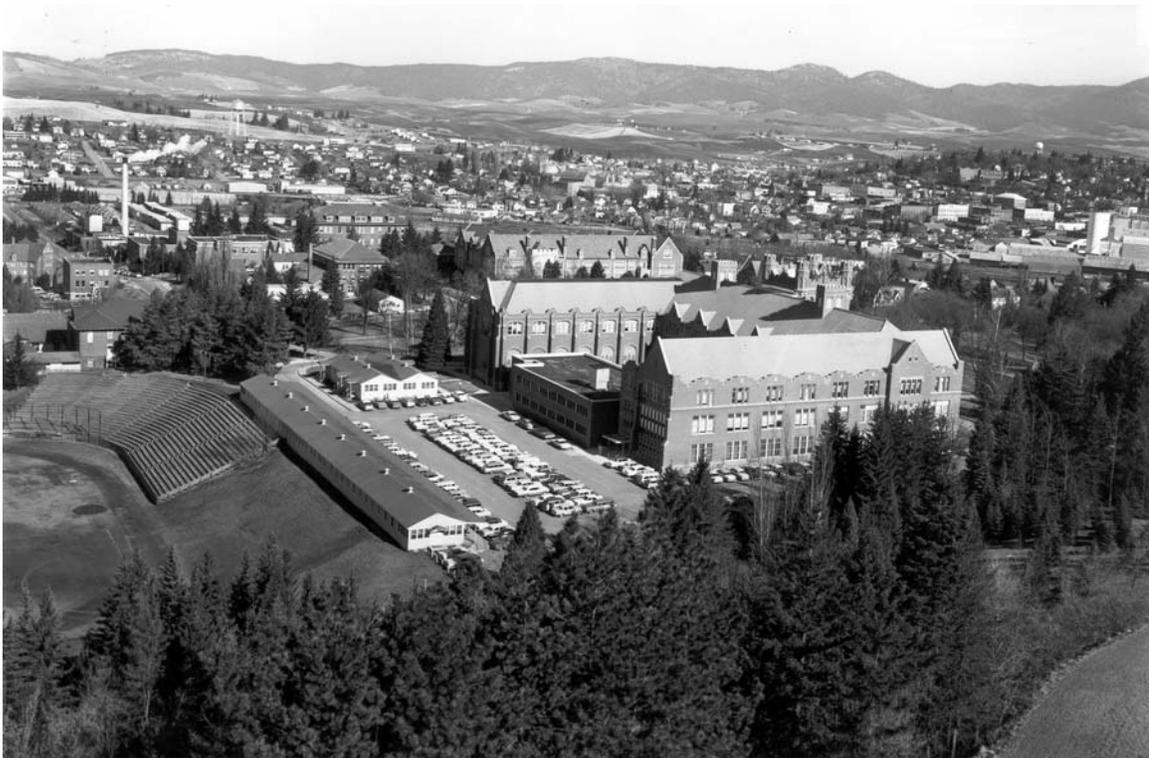
Historic panoramic view ca. 1960, with the back of the Administration Building and the Annex addition, which was constructed in the west courtyard space. Photo No. 1-2-13.

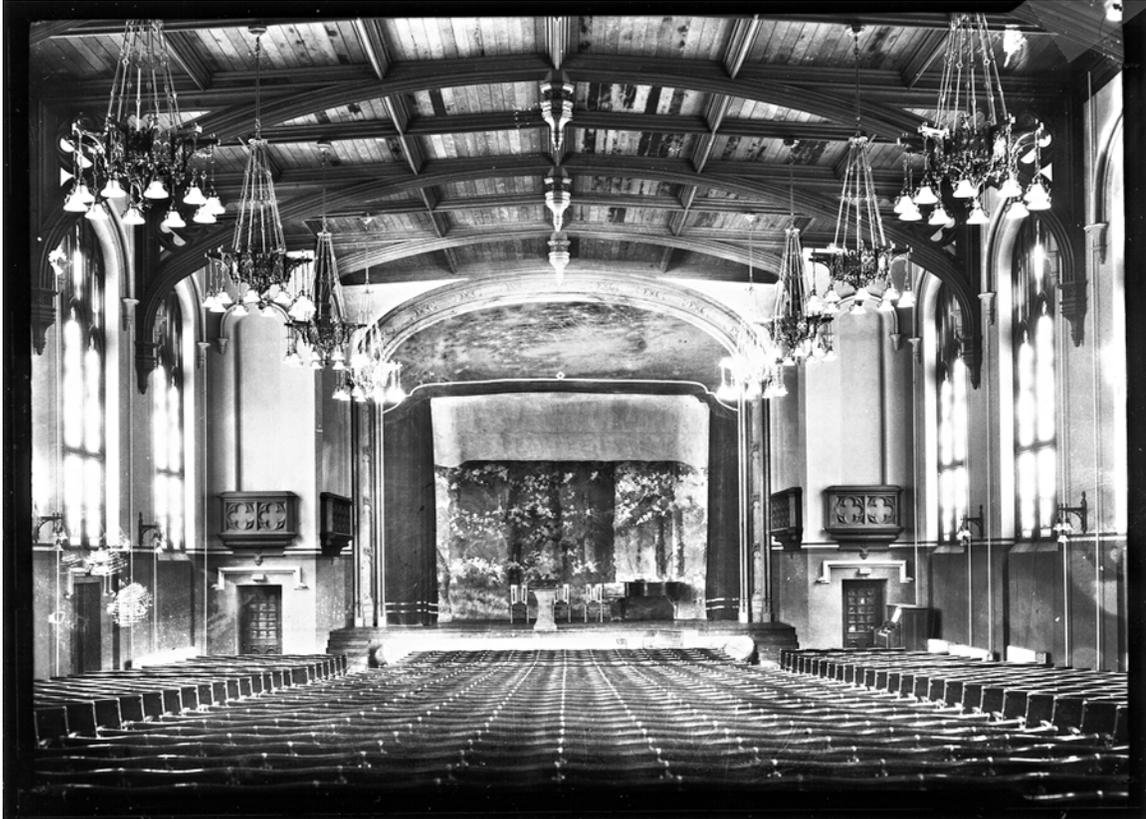
Historic photo from 1924 of the interior of the north wing Auditorium. Note the ornate, cast metal light fixtures, each with multi-rod and chain supports and ten bell shaped glass shades. It is reported that the current chandelier in the Main Stair was taken from the Auditorium. Photographer/Donor: Hodgins. Photo No. 1-52-22a.

- The Auditorium has been remodeled several times according to photographs exhibited in its Vestibule, most recently in the mid-1980s. The changes resulted in an expansion of the stage depth and removal of audience seating, relocation of the north and south exit doors, changes to lighting and stage systems, replacement of theater chairs, addition of lighting, and provision of an accessible ramp leading to the lowest area of audience seating. Although the work resulted in some removal of original decorative detail (the surrounds over window and door heads, for example), the Auditorium remains a historically and physically intact space. The Green Room and restroom spaces below the stage, for use by performers, appear original to the 1918 construction.

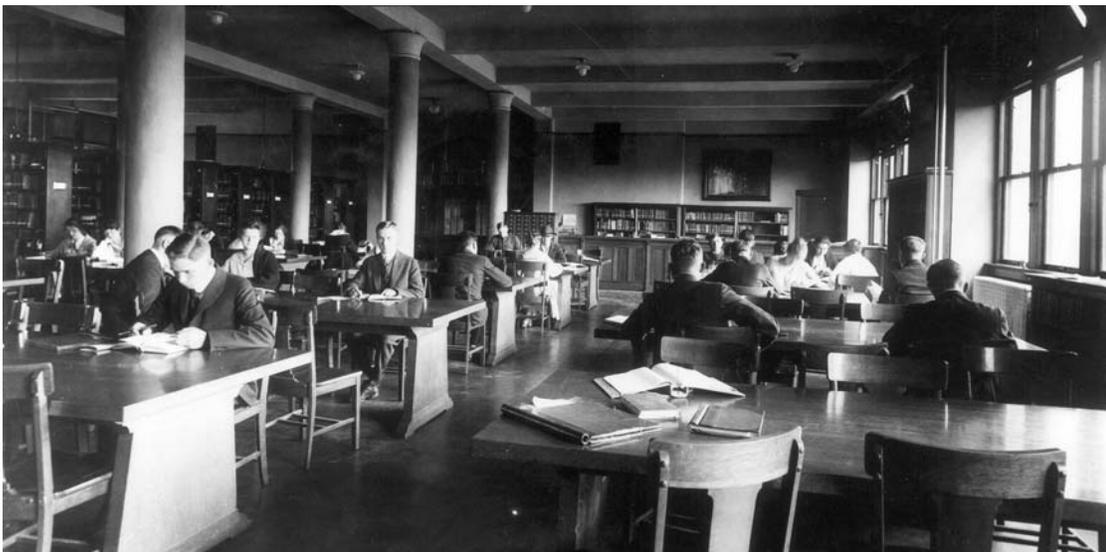
View from 1917 of the library interior (1909 -1957). Library functions, classrooms, faculty and administrative offices, and multiple uses in the Auditorium have all been housed in the Administration Building. Photo No. 1-201-2.

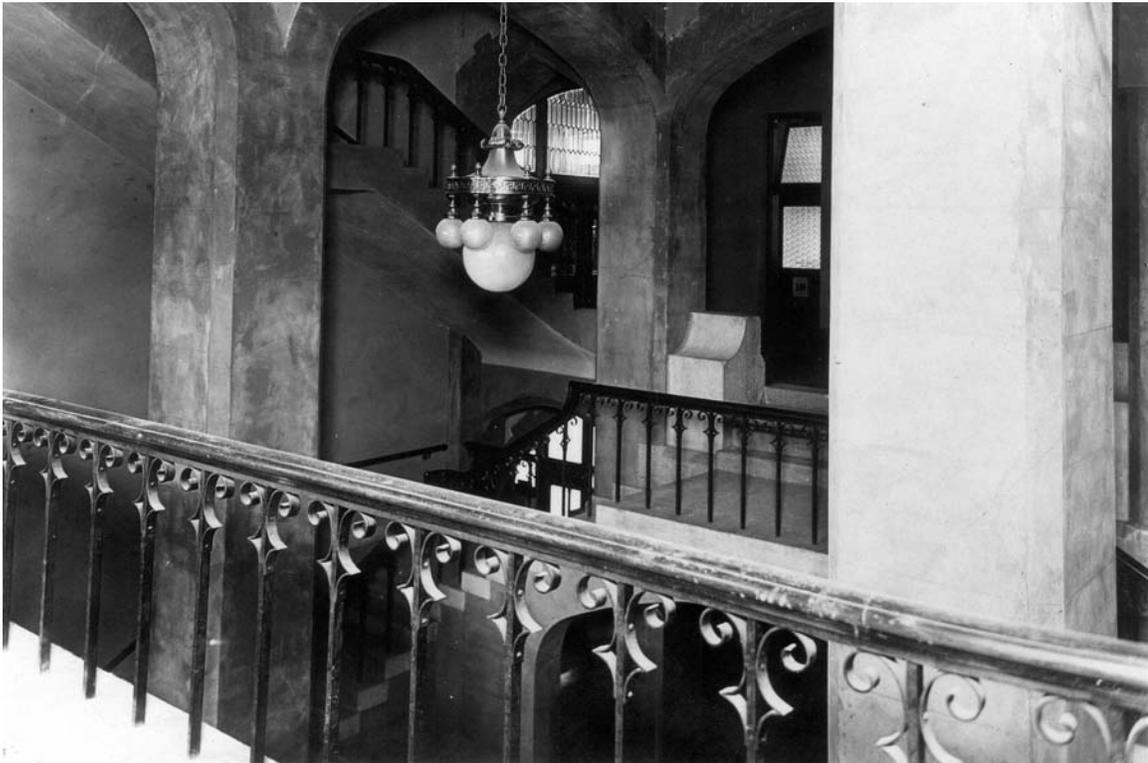
Photo from 1909 of the Main Stairway with detailed iron railing, and light fixture. Photo No. 1-52-11.

11. Interior door hardware to be consistent throughout, and with to be oil-rubbed bronze finish.
12. Raise the original low guard rail system around the Atrium opening, which consists of 30" tall, vertical iron railings by providing a solid base at the floor level of 8" to 12" in height. Reinstall the vertical rails and provide a base trim. Extend a continuous handrail at the outside wall of the stairs in the Atrium, sized to meet ADA requirements. This recommendation recognizes the life safety code and accessibility deficiencies of the current guard rail and handrail system.

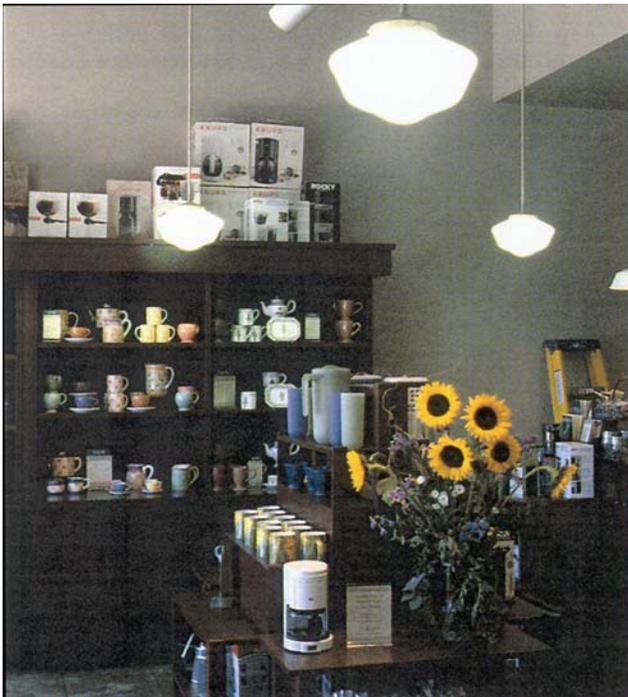
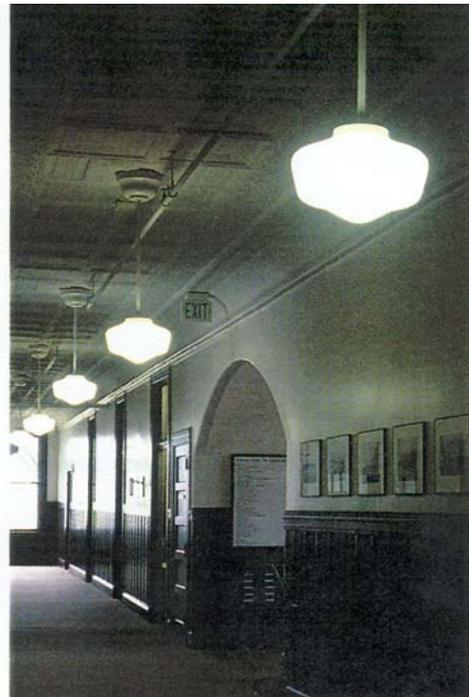
A simple, historic styled light fixture, such as the contemporary manufactured one shown above, is one approach to lighting design for the building. Lamps can be energy-conserving types.

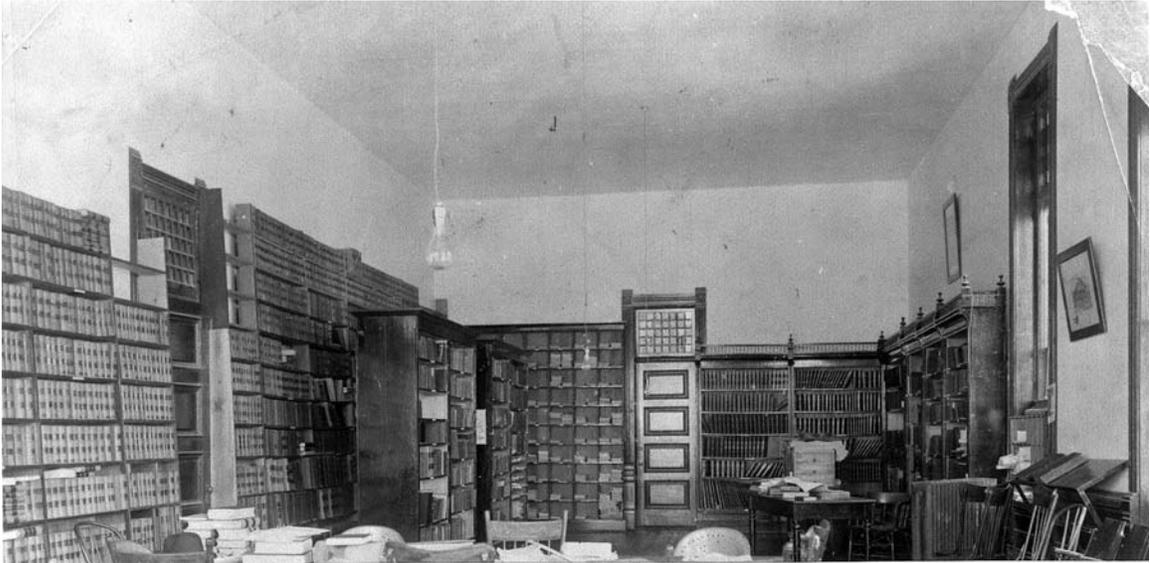
Below: This photo, taken before 1906, shows the library interior within the first Administration Building. Note the stained wood, four-panel door with leaded glass transom, and the built-in bookcases with cornice and finials. Written sources indicate the interior was finished with Redwood. Photo No. 1-201-20. Donor W. C. Edmundson.

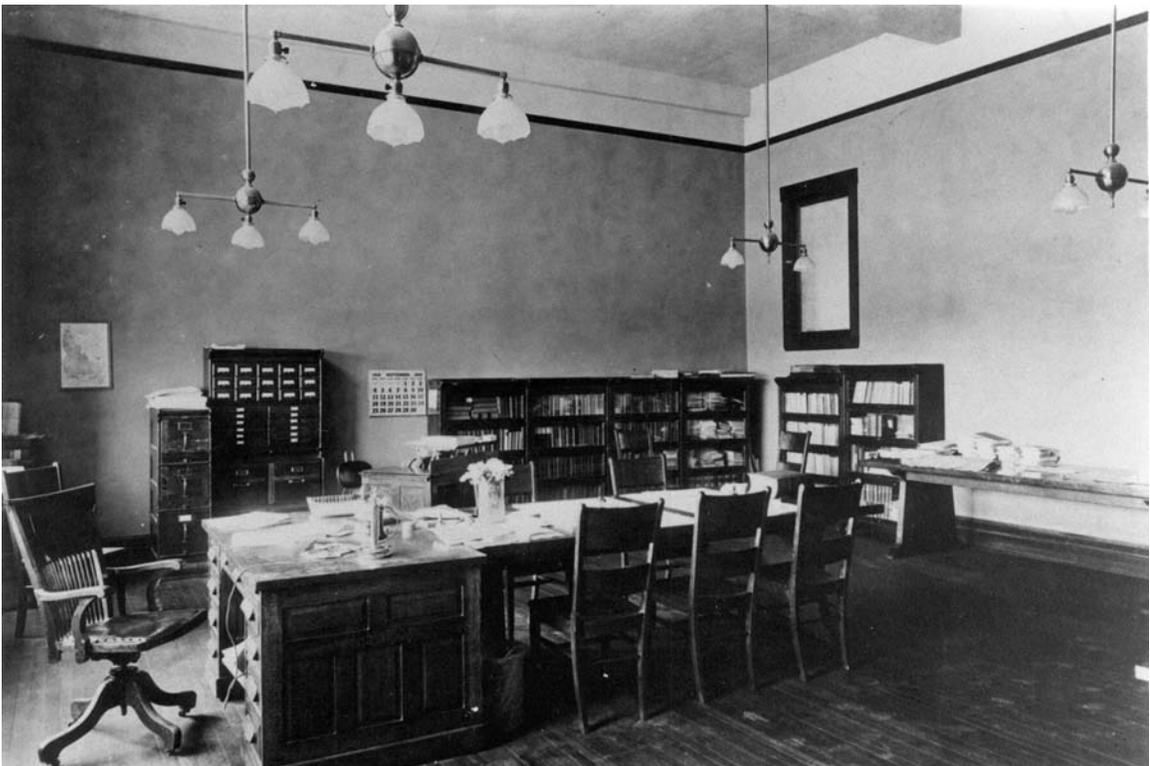
Bottom: Historic photo from 1910 of the President's Office in the Administration Building. Note the original stem-mounted light fixtures, which appear to have been modeled after earlier gas-fueled fixtures, and the "ergonomic" wood task chair.

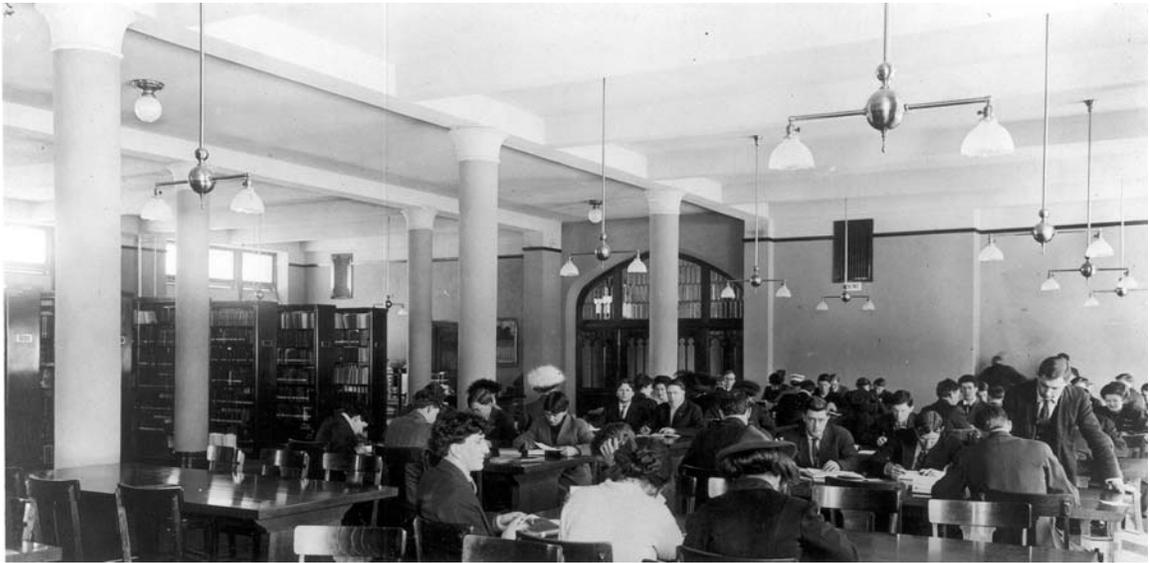
Historic interiors may offer inspiration and precedent for new interiors, casework and lighting rather than serve as literal sources. Above: Historic photo ca. 1915 of the library (1909-1957). The door in the background that appears to be an entry which then led to a corridor and exit stair. A variety of light pendant and ceiling mounted light fixtures are evident. Note also the non-reflective dark wood desk surfaces. Photo No. 1-201-32.

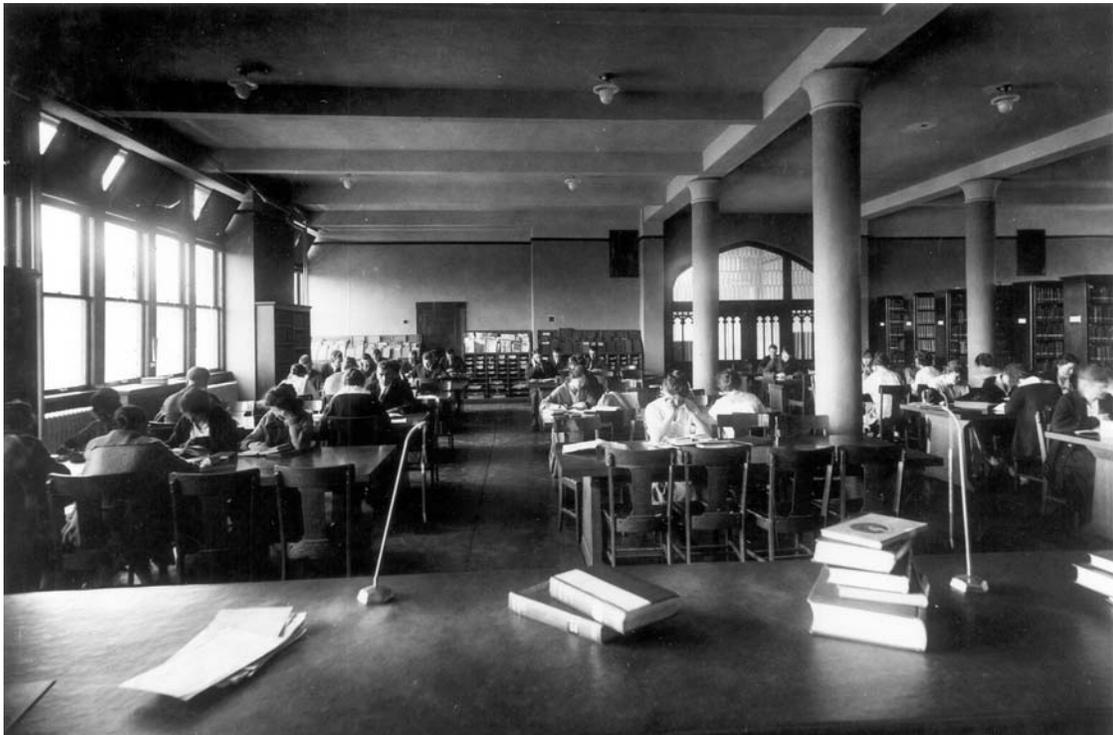
Below : photo from 1917 of the library interior. Note the light fixtures and stained wood bookshelves. Photo No. 1-201-1.

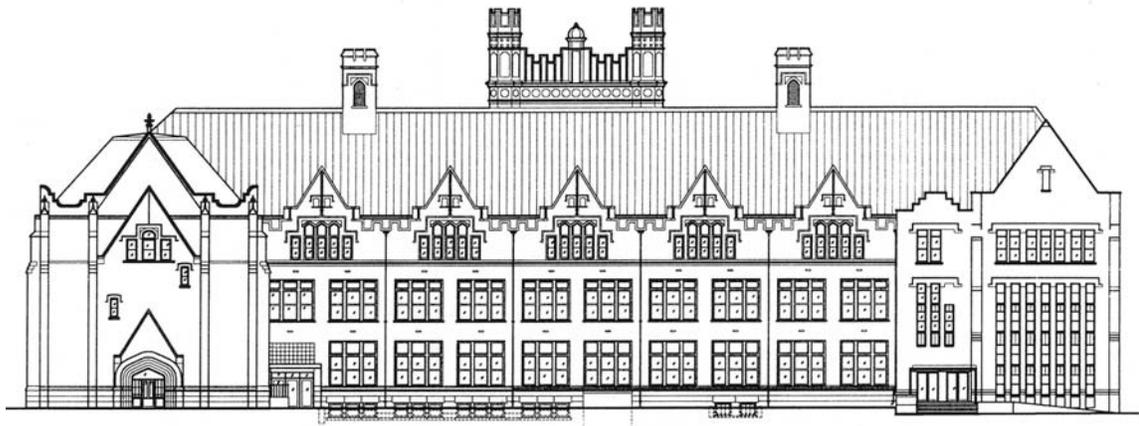
West Courtyard Elevation, Administration Building

In contrast to the new College of Business and Economics building, the west façade of the Administration Building, while symmetrical, was not composed with a distinct central bay. There is little to suggest, from this façade, that there needs to be a new access point in the middle of the building. The central location is also compromised by an original (therefore historic?) mechanical vault, which should be removed and relocated in any new scheme for the courtyard. The buildings, at their closest points, are approximately 70' apart. This narrow space, coupled with the tall façade heights of the buildings, does not provide enough physical separation to effectively create a recognizable and functional central connection.
