REQUEST FOR QUALIFICATIONS (RFQ)

SUBJECT: DPW PROJECT NO. 26250

Joint Military Science & Veterans Assistance Center

TARGHEE HALL FEASIBILITY STUDY/PROGRAM

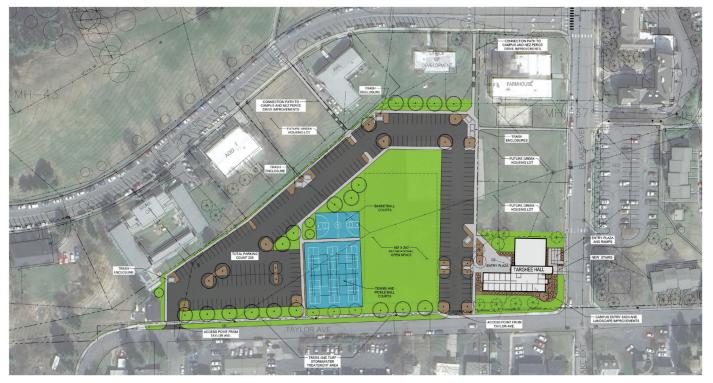
The proposed site design aims to significantly enhance Targhee Hall's functionality and provide resources for students and the new Greek Row, such as sports courts, 200+ parking stalls, and relocating all trash enclosures from Nez Perce Drive. Additionally, the site will improve pedestrian circulation for all students walking through the area to campus. From a wayfinding perspective, the southeast corner sign and building will announce to people driving to the site they have arrived on campus. Outdoor spaces adjacent to Targhee Hall will include plazas and seating that create gathering spaces for the ROTC and Veteran Services programs. The large open lawn in the center of the site will be maintained to allow ample space for the campus recreation department and cadet training.

See Appendix H for larger site plan.

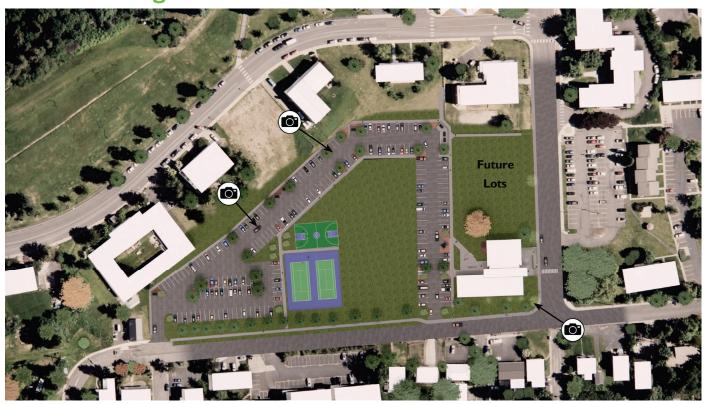
Site plan rendering of proposed site improvements.

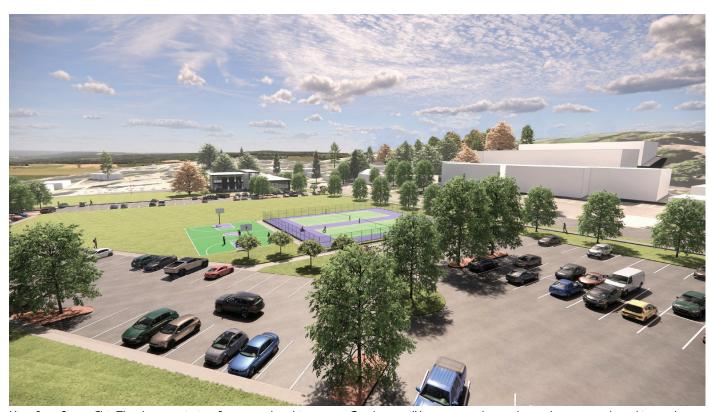
View from Sigma Chi: The close proximity of courts and parking to new Greek row will better appeal to students where currently parking and other recreational opportunities are further away.

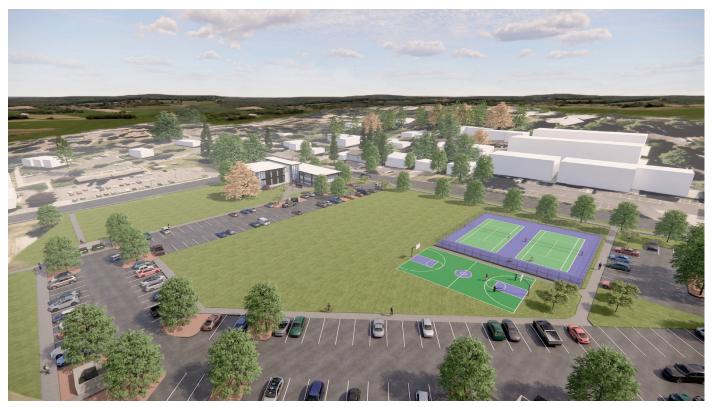
View from Northwest Corner of New Greek Row Hill: Site amenities such as parking, and trash enclosures will help support Nez Pierce Drive.

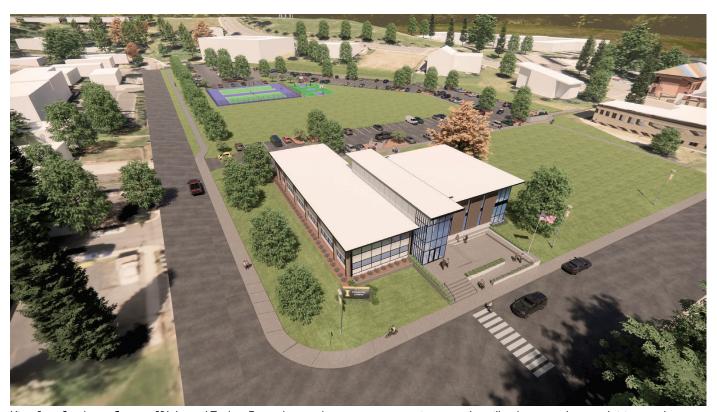
View from Southeast Corner of Blake and Taylor: Entry plaza and corner monument sign upgrades will welcome students and visitors to the campus. These improvements will also serve as a way finding point to better define campus extents.

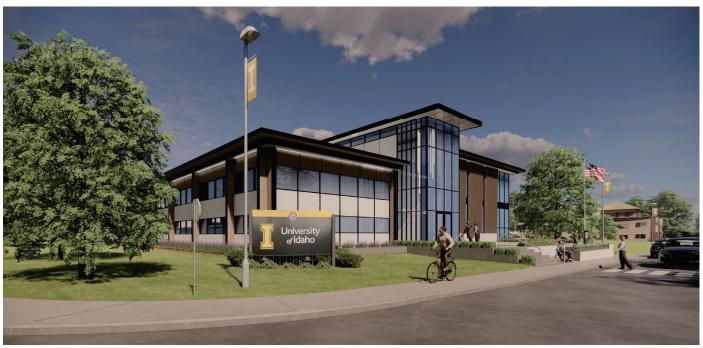
SE Concept: Campus entry sign and the east side entry. Floor height above pedestrian path will be accessed through the use of tiered ramping.

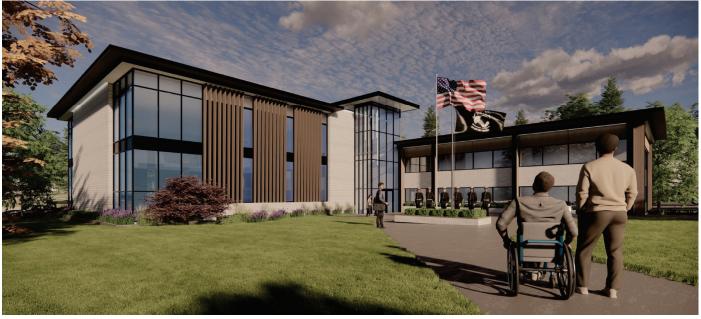
NW Concept: Entry access from what is proposed as parking and the open space that involves several functions.

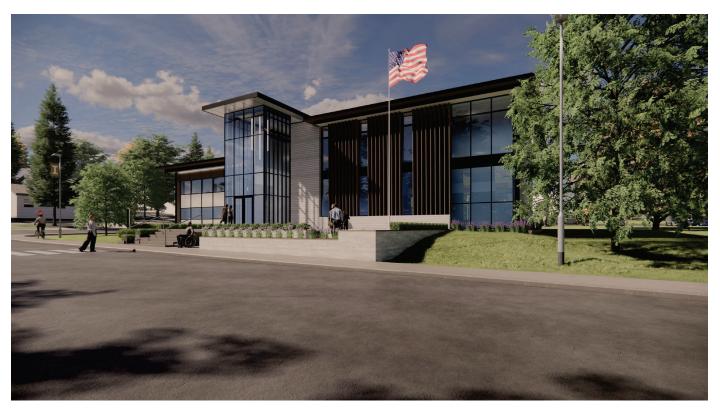
NE Concept: East side entry. Floor height above pedestrian path will be accessed through the use of tiered ramping. This provides opportunities for landscaping.

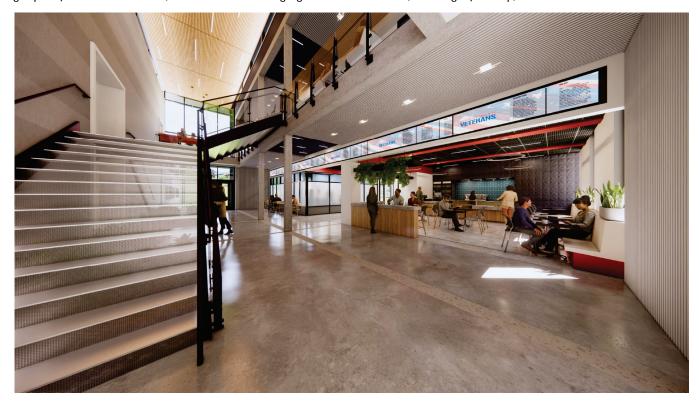
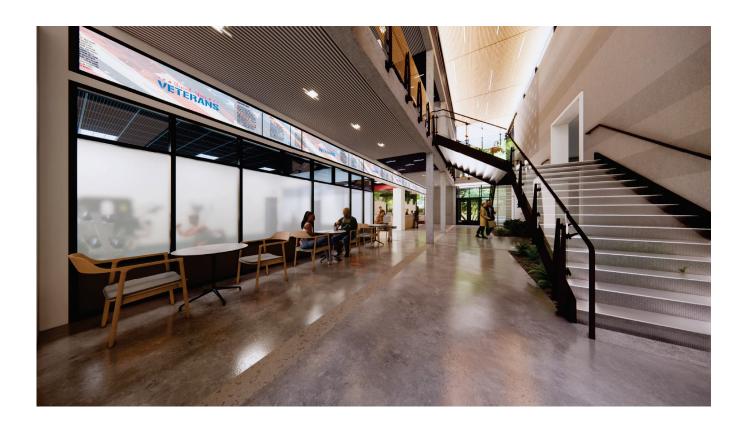
First Floor: Both the street-side and courtyard entrances lead into a welcoming lobby featuring a café, study, and gathering areas, which seamlessly connect the existing building to the new addition. This 'Connector' serves as the primary circulation space across multiple floors, highlighting key functions that Architects West aimed to showcase. The space will feature abundant natural daylight, scenic views, and will act as a conduit to all departments and common areas. The first rendering offers a perspective of the experience as you enter the building from the west, with a similar experience at the east entry, though with different functions to the north and south. The rendering's north side provides a glimpse of the Wellness Center, while the south side highlights vertical circulation, including a four-stop, two-sided elevator.

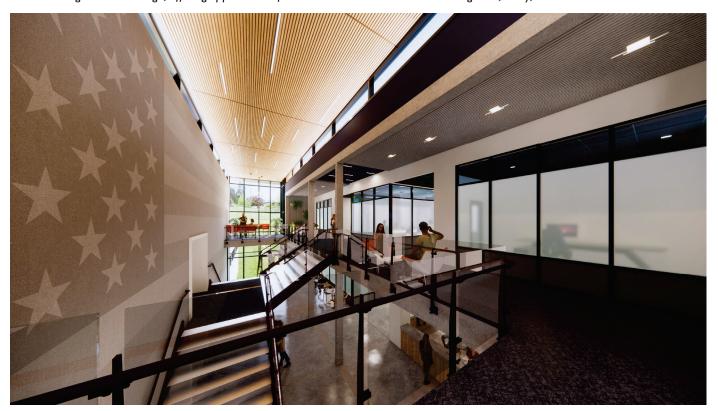
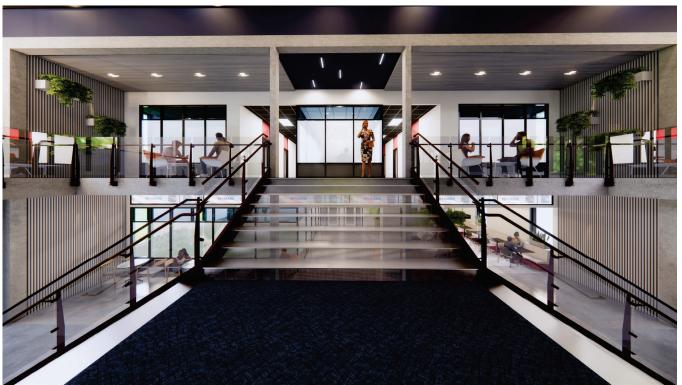
Second Floor: The second-floor connector includes open balcony lounges at each end, offering views of the new lobby, flag wall, and grand staircase, creating relaxed spaces that bridge the old and new sections of the building, and facilitate simple and convenient circulation. The second interior rendering illustrates how vertical circulation can be optimized. The floor-to-floor height in the addition is utilized to create visual interest through the stair design, offering opportunities for common areas where students can gather, study, or socialize.
